# FRIENDS OF NEW BRIGHTON MARINE LAKE

## Baseline Assessment and Rehabilitation Strategy

19th November 2024  
Draft Report Version 1.1

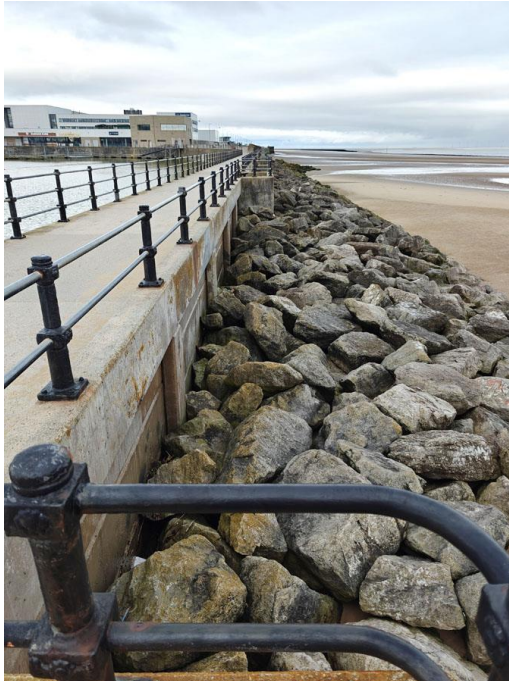
New Brighton Marine Lake (NGR SJ 30832 94331) is an impounded marine water body that was constructed around 1934 and forms a focal landscape feature of the New Brighton waterfront. The lake was formed with a combination of sandstone block walls and a piled concrete impounding dam wall along its northern bank. A boulder sea defence provides seaward protection of the impounding wall (see Photograph 1).

**Photograph 1: Boulder Sea Defences along the Northern Impounding Wall.**

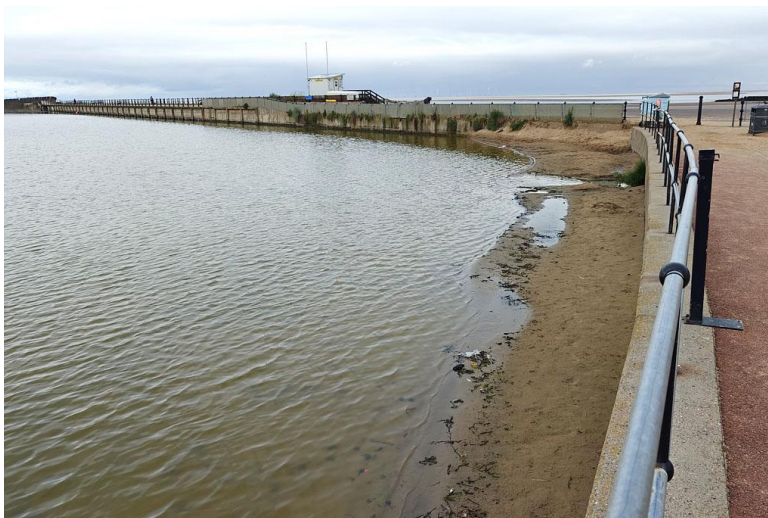
The lake covers an area of approximately 3.425 ha with a relatively uniform depth of around 2m. Accumulations of silt are relatively low within the lake (up to a depth of around 35cm), with the exception of the north bank and north-east corner of the lake where there are deposits of wind-blown sand from the adjacent beach. (See Photograph 2).

**Photograph 2: Accumulations of wind-blown sand in the north-east corner of the lake.**

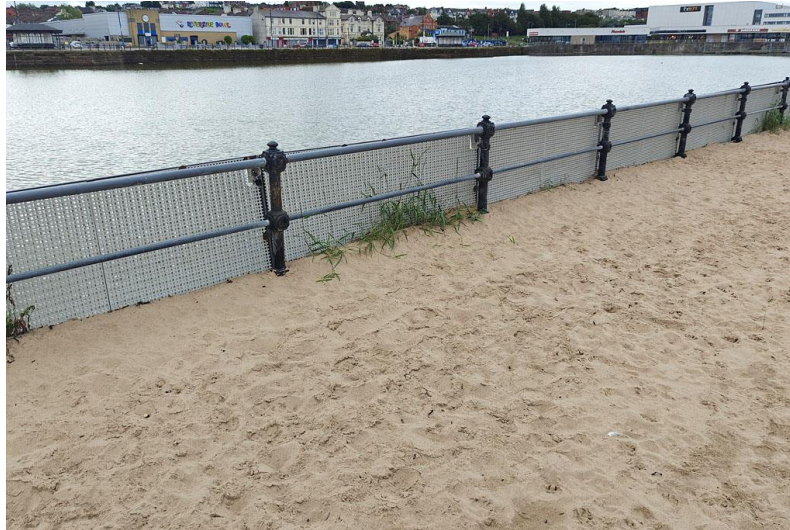
A fine mesh fencing has been installed along the railings in the north-east corner as an attempt to reduce wind-blown sand inputs into the lake (see Photograph 3).

**Photograph 3: Mesh railing panels installed to reduce windblown sand inputs into the lake**

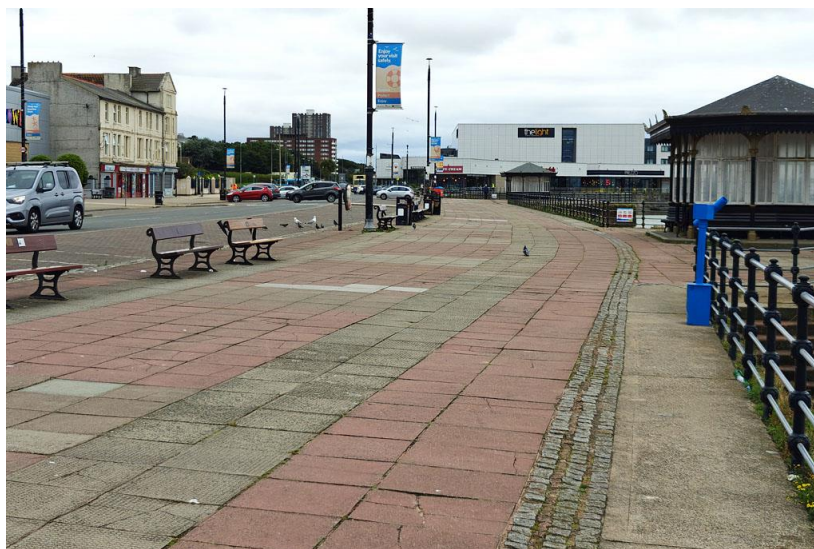
The water supply to the lake is from two keys sources which are freshwater surface drainage from the surrounding hard standing areas and saltwater inputs from a series of 19(no.) inflow pipes along the north wall. The extent of the surface water drainage catchment to the lake is currently unknown but is likely to include hardstanding perimeter footpaths to the south of lake (see Photograph 4), and surface water from areas of the Marine Point development that is thought to discharge into the lake via two large flap valved pipes located at its eastern end (see Photograph 5). The areas of the development at the western end of the lake that drain surface water and discharge it into the lake is unknown.

**Photograph 4: Hard standing pedestrian areas on southern surrounds that drain towards the lake.**

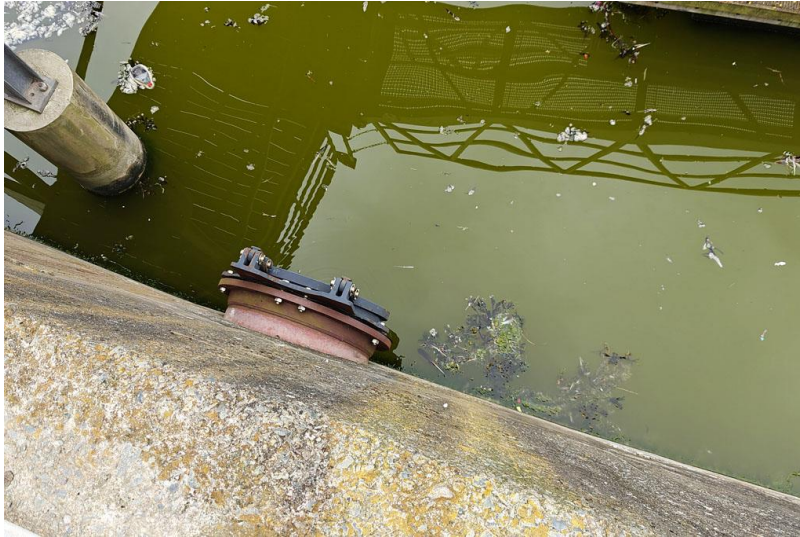
**Photograph 5: One of two drainage inflow pipes located at the western end of the lake.**

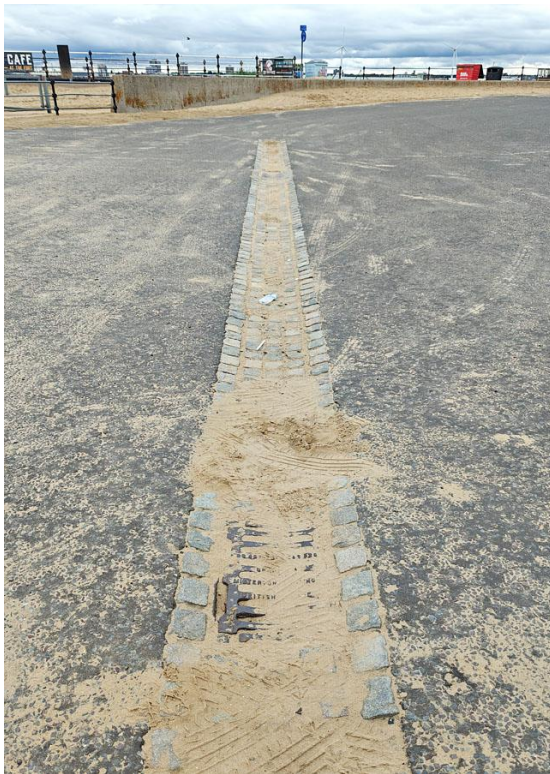
Some of the surface drainage from Perch Rock carpark also drains into the north-eastern corner of the lake via a gully drain (See Photograph 6). This drain is subject to frequent blockage by wind-blown sand causing localised surface water flooding at the northern end of the car park. It is not known if this drain incorporates an oil inceptor to remove hydrocarbon contamination from car park surface drainage, prior to discharge into the lake.

**Photograph 6: Sand blocked gully drain at the north end of Perch Rock car park.**

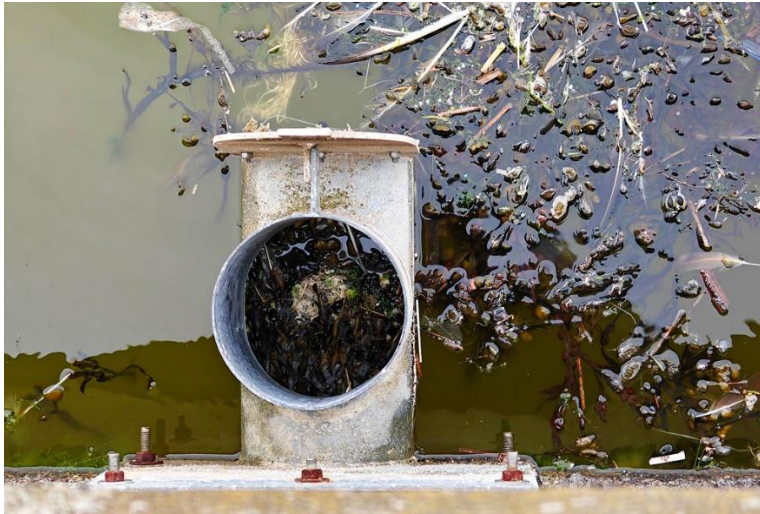
Seawater inputs into the lake are through a series of 19(no) pipes set into the northern dock wall. These pipes are fitted with a flap valve on the lake side (most of which have been fixed to open) (see Photograph 7). The pipes and also reported to have another internal valve, that in various states of disrepair, which have also been left open.

**Photograph 7: Open flap valve on inflow pipe on northern wall of lake.**

Problems frequently occur with blocking of the inflow pipes with debris and sediment and they are now routinely cleared by volunteers.

Debris also enters lake during through the 19(no) inflow pipes along the north wall whilst in-lake litter also causes lakeside blockages of the pipes. The pipes are fitted with flap valves on the lake side of the pipe which are in various states of repair, and which are now held open. There are benefits in having the pipes open in that it allows any freshwater inputs accumulating towards the surface of the lake above the denser saltwater, to be discharged to the beach. However, it does make the pipes vulnerable to blockage by both debris and silt accumulations, that requires regular cleaning to be undertaken.

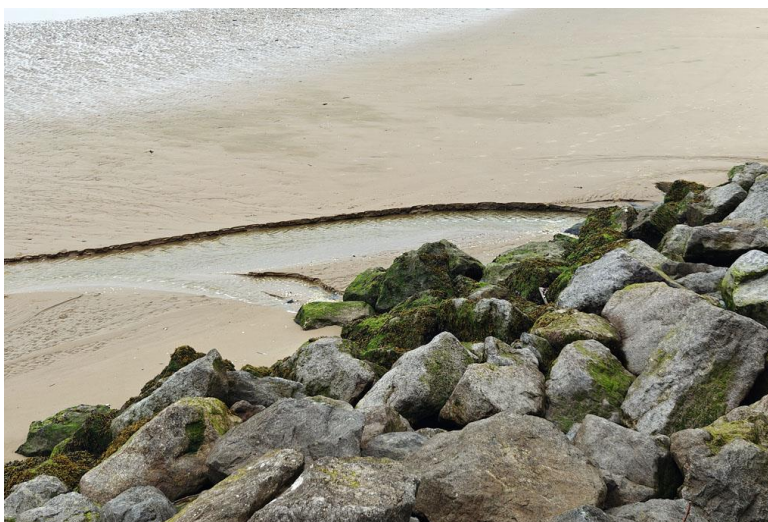
Impoundment of sea water occurs during high tide periods when the tide height is greater than 9m. For many years these inflow pipes were left closed which caused the lake to turn brackish with the associated water quality issues and decline in ecological diversity. At the time of the visit, water was observed to be discharging from the lake to the beach (see Photograph 8) as water levels will have been temporarily increased by seawater impoundment from the previous high tide which was greater than 9m. At high tide (9.8m at 13:47) during the visit, water was observed impounding into the lake through the majority of the northern wall pipes. This can

**Photograph 8: Water discharging from marine lake onto New Brighton beach during the visit.**

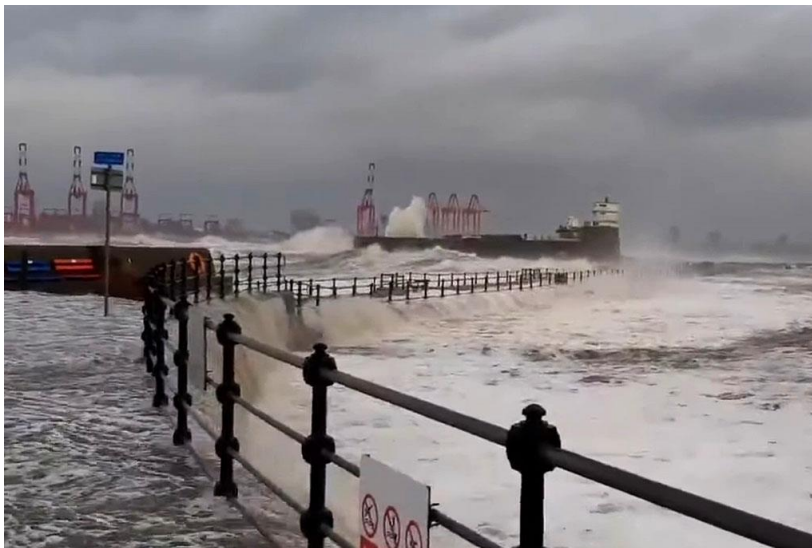
NBML also form part of the local coastal flooding protection system and is therefore subject to periodic inundation with large volumes of seawater during storm events. This can be through direct overtopping of the northern impounding wall. Waves overtopping the sea wall onto Harrison drive promenade can occur on spring tides under north or north-west gale force winds. The resultant seawater flows along the promenade towards and into north-western corner of the lake (see Photograph 9), excess water in the lake then either discharges through the outflow in the south-east corner (see Photograph 10) or via the slipway at the western side of lake, across Perch Rock carpark and back into the River Mersey. It is currently unknown where the in-lake outflow structure discharges to. The most recent such storm event prior to the monitoring visit was on the 9th April 2024.

Photograph 9: Storm driven seawater inundation of the marine lake.

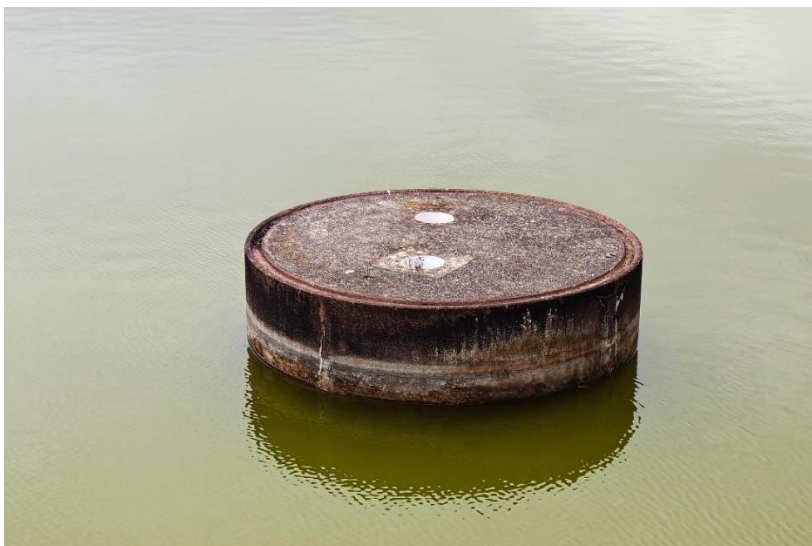
Photograph 10 overflow structure in south-east corner of the lake.

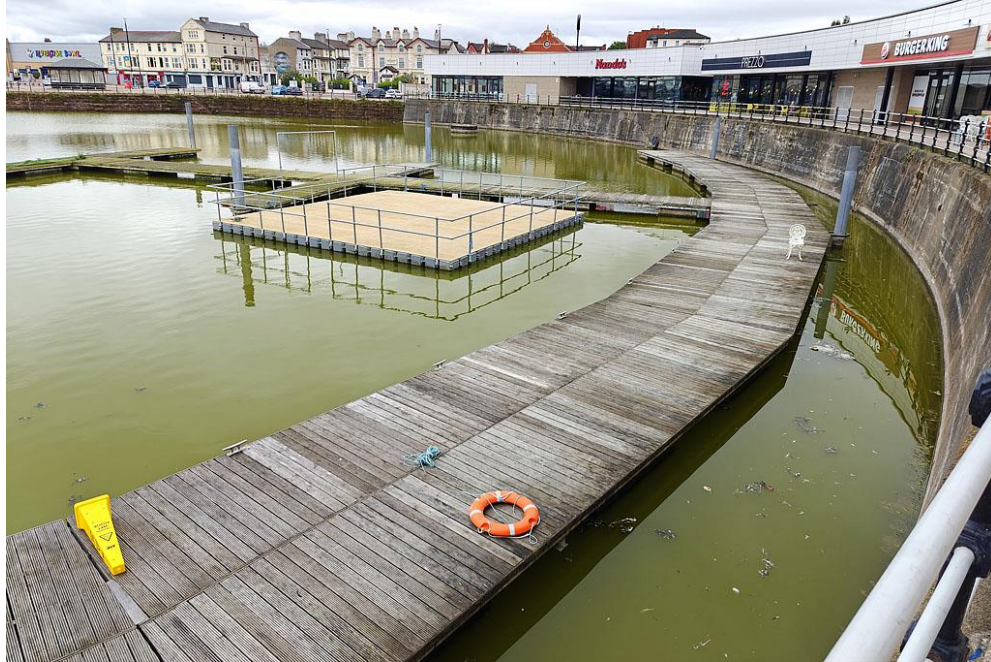
Photograph 11: Floating pontoon at the eastern end of the lake.

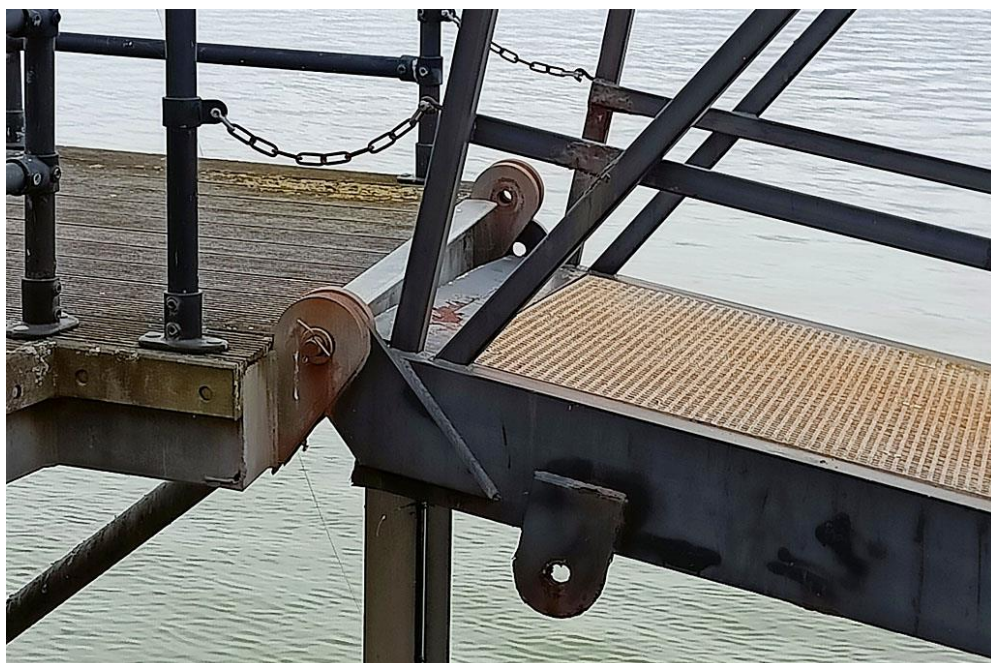
Access to the water in the marine lake is limited, given that the steps on southern bank have been sealed off, and restricted to the slipway at the eastern end and the floating pontoon structure at the western end (see Photograph 11). The pontoon is currently closed to access due to safety concerns as one of the retaining pins on the access ramp has been lost (see Photograph 12)

Photograph 12: Showing missing retaining pin on access ramp

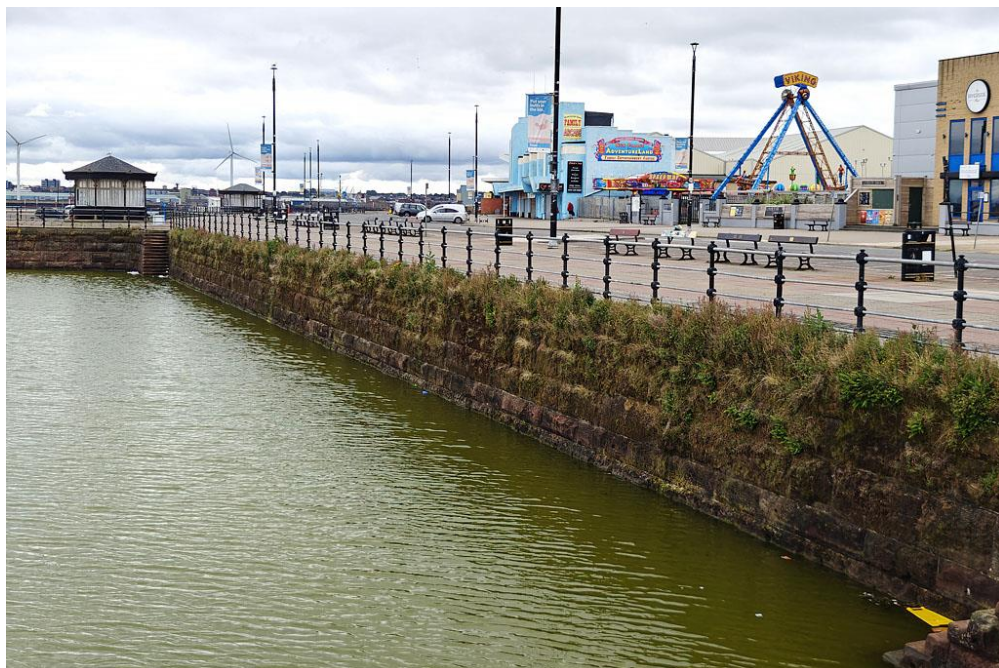
The red sandstone block wall that forms the southern wall of NBML showed significant terrestrial plant growth, together with hardstanding areas around the Victorian seating shelters. This weed growth reduced the overall visual quality of the site and gives the visual appearance of a general lack of maintenance (see Photograph 13). The plant growth along the southern wall is likely to further compromise the integrity of any mortar between the sandstone blocks with time.

**Photograph 13: Weed growth along the southern blockwork wall.**

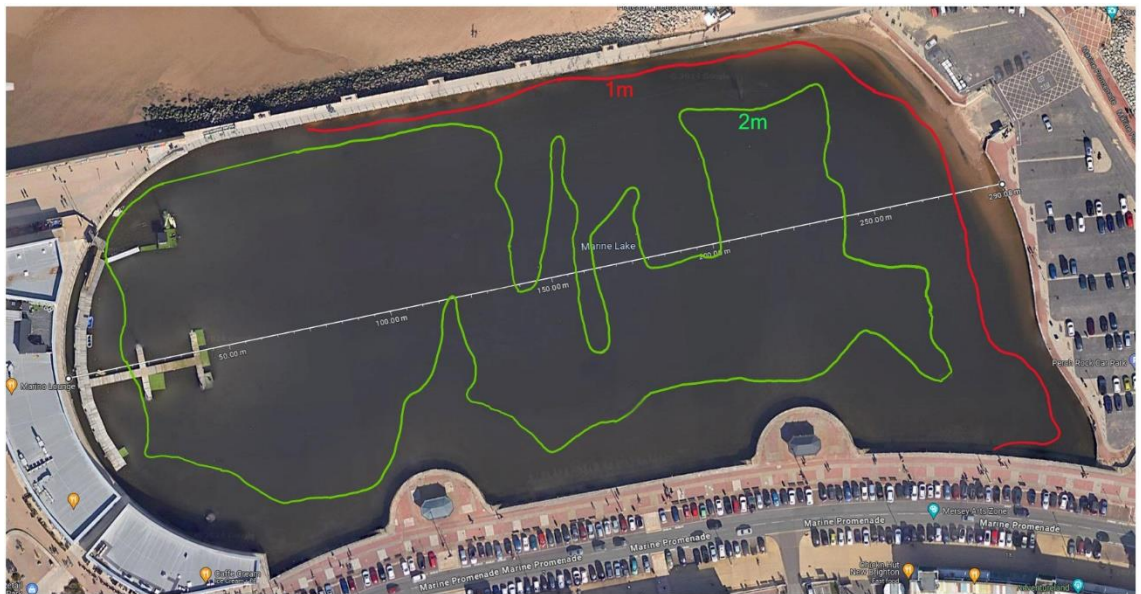
The surveyed transect profiles of water depth and sediment depth are presented in Appendix A. Water depth within the lake was found to be relatively uniform and shallow across the entire lake area. The average recorded water depth (based on a water level at the bottom of the inflow pipes which is the main route of lake discharge) was 1.78m and the maximum depth 2.25m. A substantial area of the lake area has a water depth of around 2m. There is some shallowing of the lake at its eastern end and along its northern bank which appears to be mainly from deposition of wind-blown sand into the lake from the adjacent beach to the north and some settlement of sediment impounded through the inflow pipes. From the water depth data, a contour map has been produced which is presented in Figure 3.

**Figure 3: Contour plot of Water Depths**

Sediment accumulations within the lake were found to be low and unevenly distributed across the lake with a maximum recorded depth of 30cms, which is not significant in relation to the retained water depth.

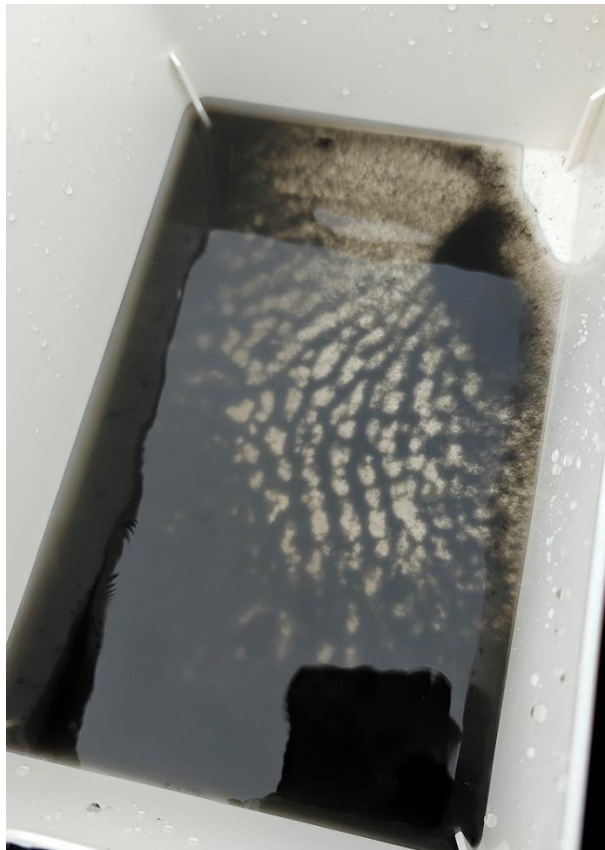
A sample of sediment was collected for visual inspection from the lake-bed using a benthic grab sampler.. The sediment recovered was a brown-black clay/ sandy silt with finely divided organic material and was odorous with hydrogen sulphide (see Photograph 14). These features of sediment are indicative of the development of low oxygen (anoxic) conditions. The presence of anoxic sediments has implications towards water chemistry as they readily the mobilise of nutrients used for plant growth (algae), contributing to algae blooms, and release pollutants (i.e metals) from the sediment into the overlying water.

Photograph 14: Anoxic sediment sample collected from the lake-bed
