# FRIENDS OF NEW BRIGHTON MARINE LAKE

## Baseline Assessment and Rehabilitation Strategy

19th November 2024  
Draft Report Version 1.1

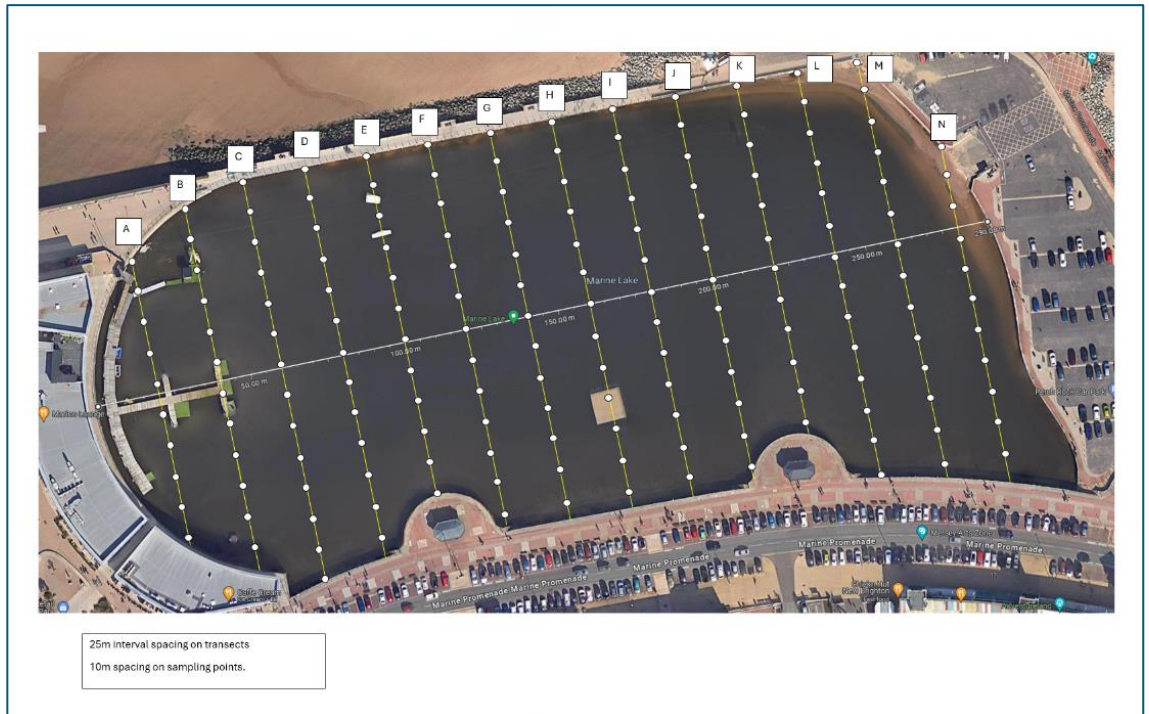
Figure 1: Locations of Water and Sediment Survey Transects and Sampling points.

Water and sediment depth surveys were undertaken by boat across the entire marine lake area. The purpose of the survey was to establish retained water depths and sediment depths within the waterbody. This information is important in examining how the waterbody functions, its suitability for recreation activities, provides important information for the design of any aeration / mixing system and determines the degree of lake siltation. Measurements were recorded by ranging pole along a series of transects spaced at 25m intervals in a north to south direction across the lake. Measurements of water depth and sediment depth were recorded by ranging pole at 10m intervals along each transect line (see Figure 1).

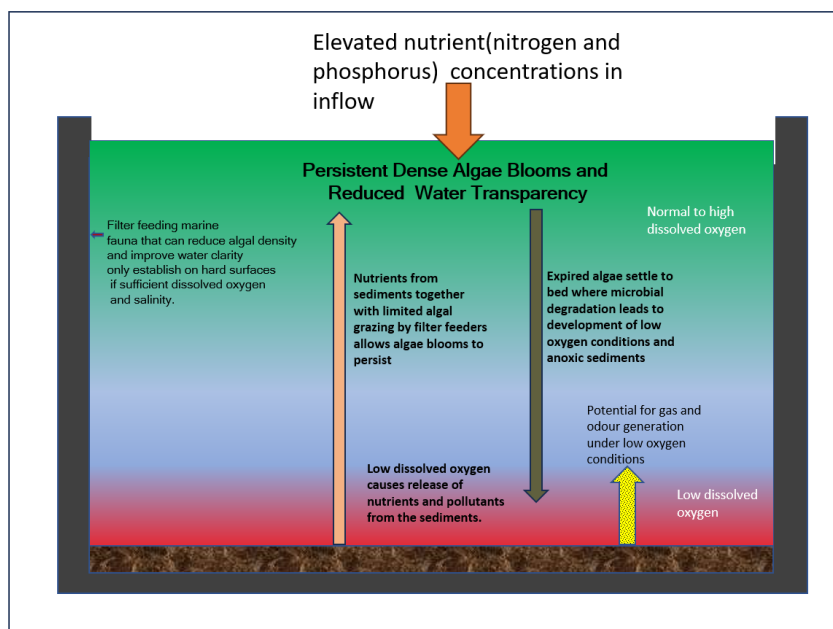
**Figure 4: Common Processes in a Nutrient Enriched Marine Lake.**

In marine systems, nitrogen tends to be the limiting nutrient for algae growth. Where elevated concentration of nitrogen are present, dense algae blooms can develop causing low transparency and cause significant fluctuations in dissolved oxygen that have numerous impacts on both water and sediment chemistry. The algae show excessive growth in the nutrient enriched conditions and expired cells settle towards the bed of the lake where they are degraded by bacteria that utilise oxygen. This can cause low oxygen conditions to develop across the lake-bed leading to gas and odour generation and also cause pollutants and nutrients, that were previously bound to sediments, to be released back in water. This is a process known as internal loading. The released nutrients then encourage further algae growth, and a cycle develops (see Figure 4).

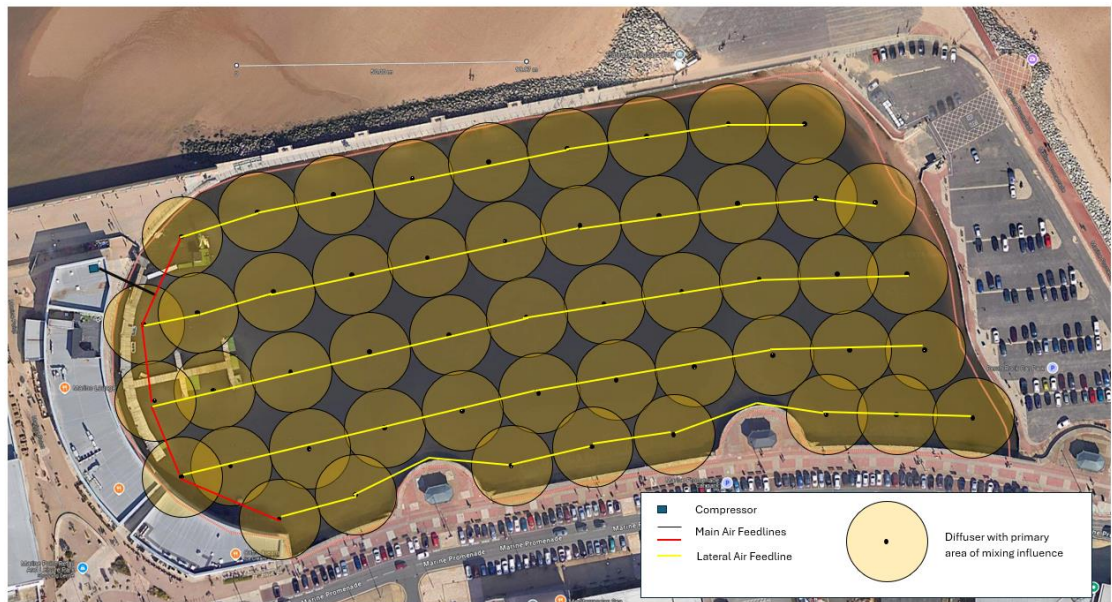
**Figure 5: Design Layout for a Diffuser-based Aeration / Mixing System**

A provisional design layout for NBML is presented in Figure 5. It should be noted the design presented is based on the ISS Flowthrough system which is unique in that it is a self-balancing system in terms of airflow and allows the correct volume of air to be delivered to multiple diffusers on a single airline. This ensures the correct volume of air

A provisional budget cost for the system is provided in Appendix C but a full detailed costed proposal can be provided on request from ISS Flowthrough.
